**CONNECTICUT RIVER BASIN
WILLIAMSBURG, MASSACHUSETTS**

**MOUNTAIN STREET RESERVOIR DAM
MA 00082**

**MOUNTAIN STREET RESERVOIR DIKES
MA 01295**

**PHASE I INSPECTION REPORT
NATIONAL DAM INSPECTION PROGRAM**

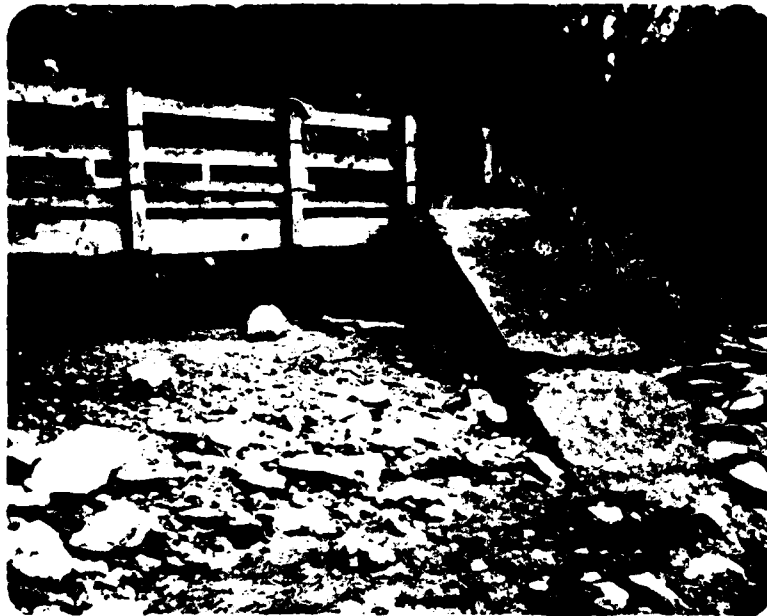
inspection, water was not discharging over the spillway. The concrete and stone masonry on the crest of the spillway was covered with soil up to the top of the stoplog. The concrete of the training walls is spalled and eroded at and below the normal pool level. A 1-inch wide horizontal crack extends completely across the right training wall (see Photograph No. 7). The timber vehicular bridge over the spillway was in fair condition. There is access to the stoplog from both spillway training walls which would permit removal of the boards during periods of high flow. At the present time the stoplog could not be removed because of the sediment in the spillway channel. The crest of the spillway contained some rubbish and wood debris.

NO. 7 SPILLWAY (NOTE CRACK IN TRAINING WALL)

- (5) Repair all spalled and deteriorated concrete on the gatehouse and the crack in the right training wall of the spillway.
 - (6) Remove accumulated soil, brush, vegetation, debris and loose stone from the crest and discharge channel of the spillway. The stoplog should also be removed.
